Welcome to Oregon

And a Look at Our R06A Experience

Corey Withroe
Oregon DOT – 503 986 3339
corey.r.withroe@odot.state.or.us

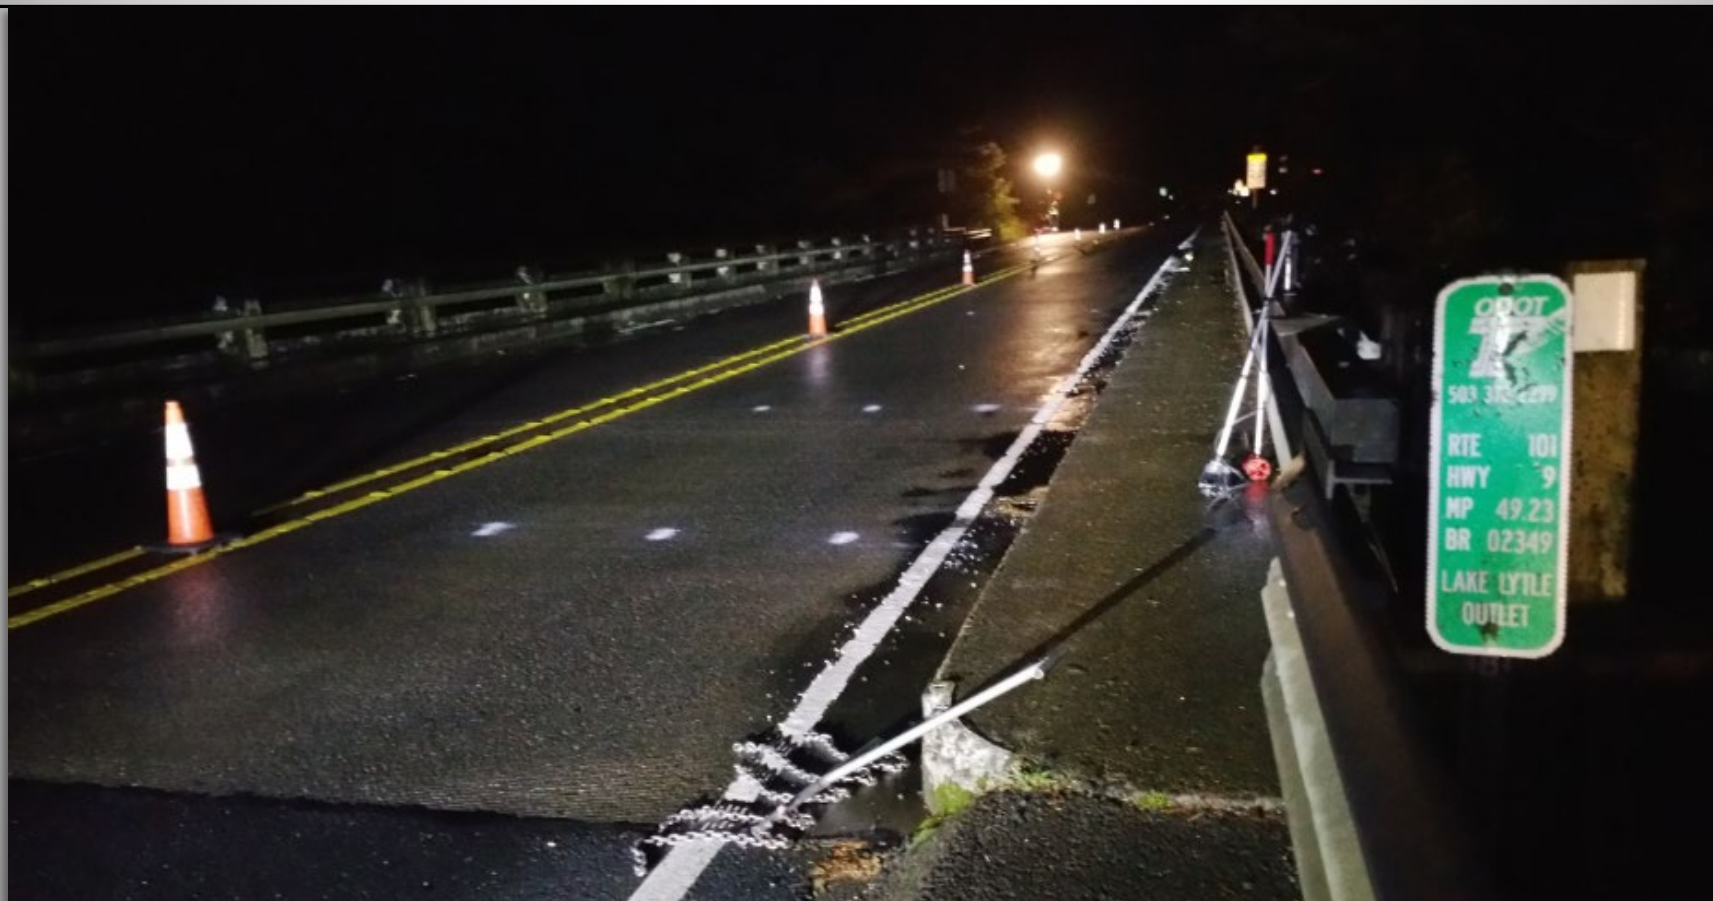
Figure 17

Image 5: chain drag and impact echo on Br 023948

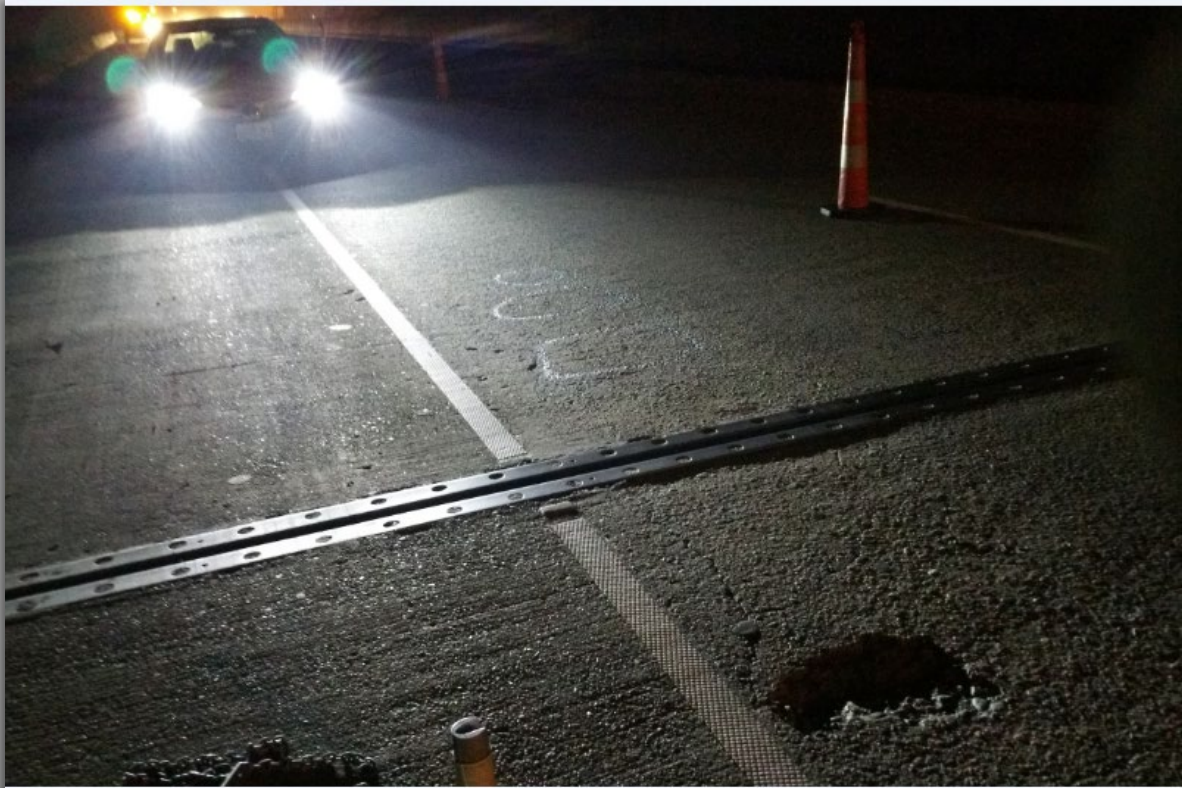
Image 14

Spall with exposed rebar appears as Delam of different shape on map

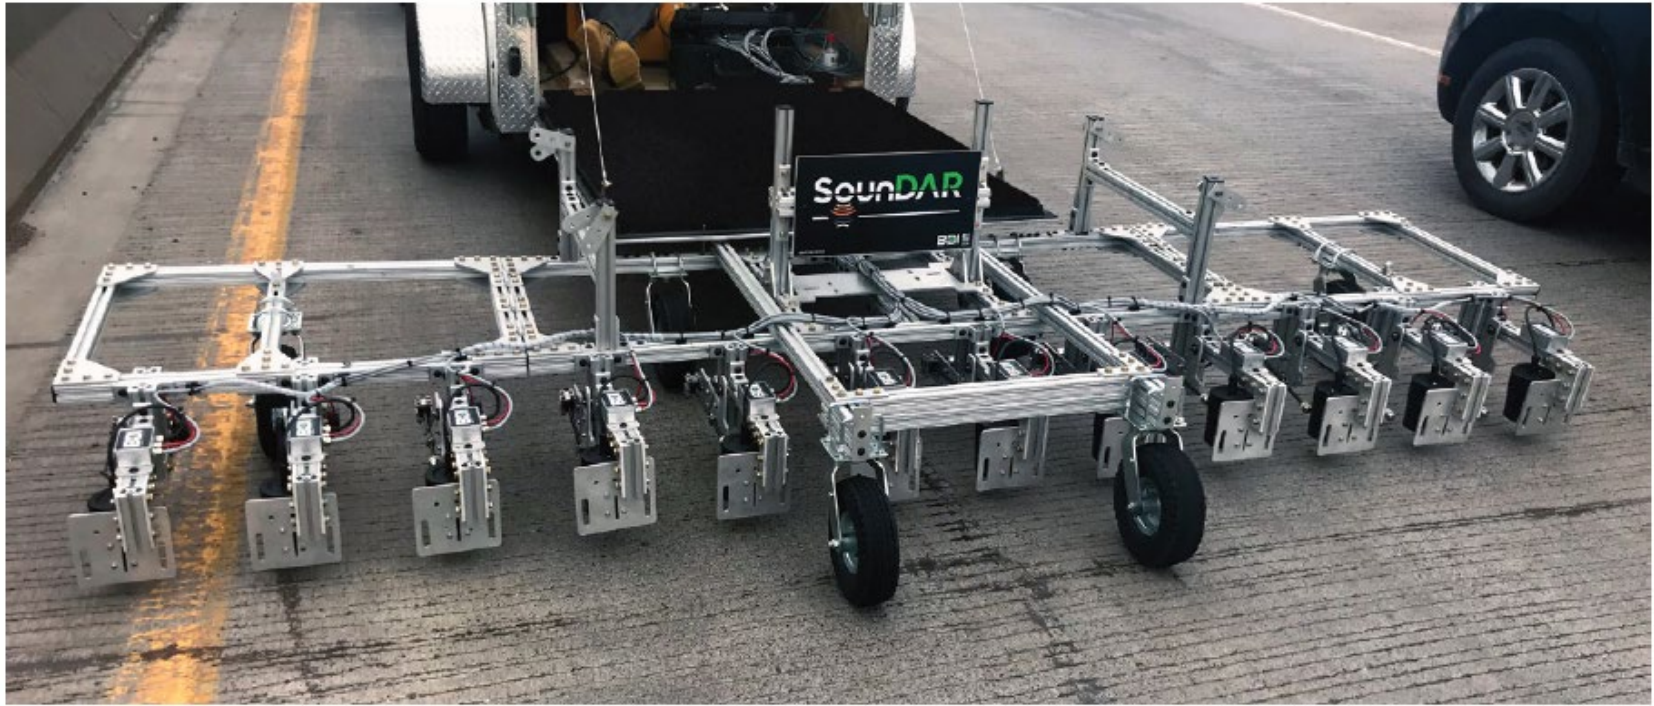
Image 35

Traffic noise proved to limit effectiveness of the human ear as a sensor—with or without earplugs.

Manual Sounding – Note earplugs

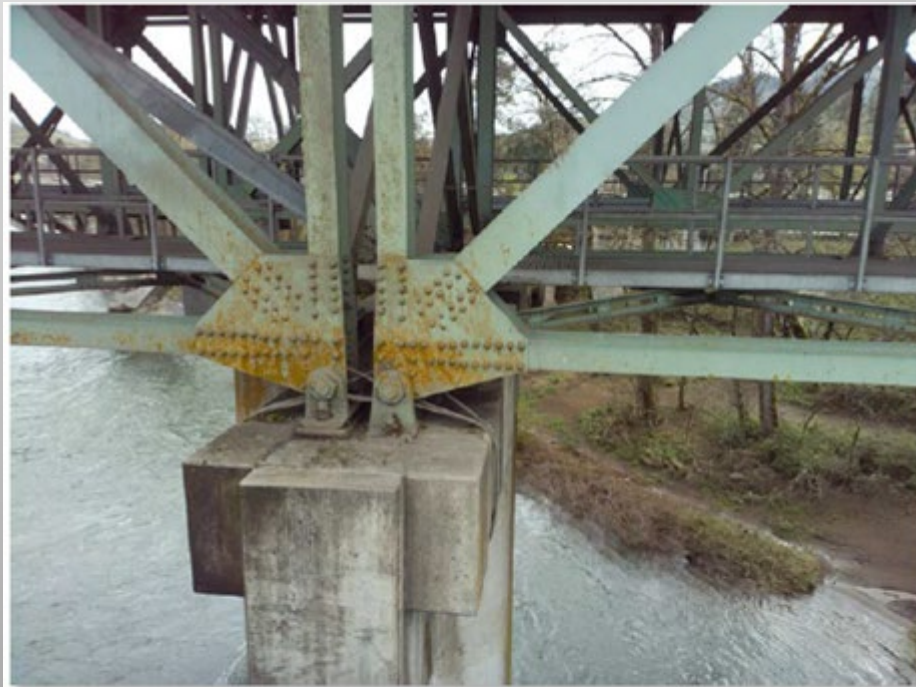
Southern bent pin connection. Taken from senseFly albris main HD camera. Focal length: 8 mm, 35mm equivalent: 25 mm. (Full image)
